Title: Investigation of Biodeterioration in Indonesian Wooden Structures

Place of survey: Yogyakarta (Indonesia)

Member: Takuro Mori (Assistant Professor, Research Institute for Sustainable Humanosphere, Kyoto University)

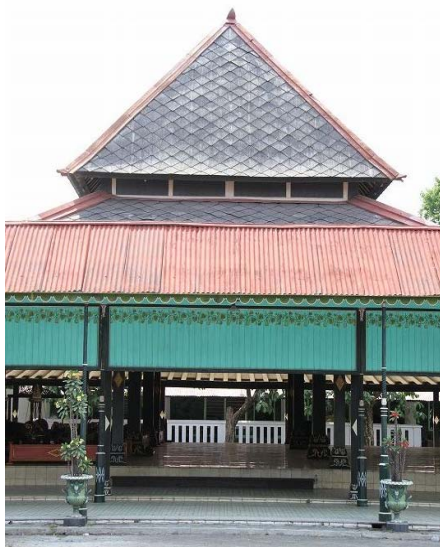
Figure 1. Sultan's palace joglo at Srimanganti Hall

First, an example from the building data of the five palaces is presented. Figure 1 depicts the building. It is used for sultans to welcome the arrival of important guests. It was built approximately 170 years ago. Table 1 presents the results of moisture content and ultrasonic velocity. The post location is illustrated in Figure 4.

Visual investigation revealed that the post had been attacked by fungi and drywood termites. The moisture content indicated that the bottom had more moisture than the top. Some posts had a moisture content that exceeded 28%. These parts are considered to be at high risk of deterioration as a result of

fungi. The ultrasonic velocity was measured to be between 1500 and 2100 m/s. The relationship between moisture content and ultrasonic velocity was poor. Some parts were measured to be approximately 1000 m/s or less, and, as such, it was assumed that they had been damaged by fungi and/or drywood termites. Low ultrasonic velocity values were only obtained at the bottom of the posts.

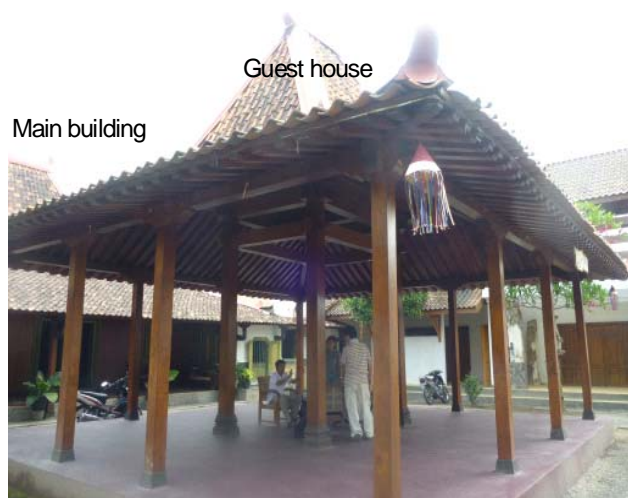
Figure 2. Joglo guest house and main building

For the house-style buildings, damage to the teak posts caused by drywood termites or fungi was observed by visual inspection of the four guest houses and two main buildings. All visible posts in the six joglo buildings were investigated by measuring the moisture content and ultrasonic velocity. Figure 5 depicts an example of one of the sixteen posts in one of these joglo buildings constructed approximately 200 years ago.

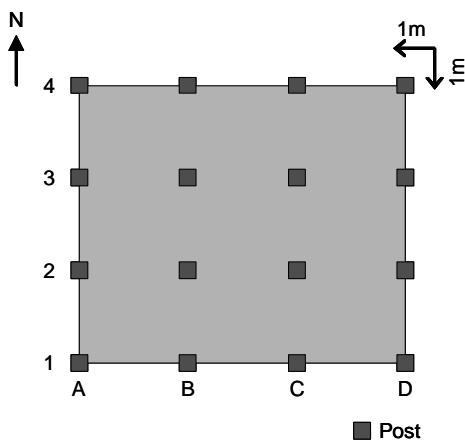
Figure 5. Location of teak posts in the joglo-style guest house

The moisture content and ultrasonic velocity of the sixteen posts in the guest house are presented in Table 2. The highest moisture content was measured at the bottom position 300 mm from the floor; the

moisture content decreased in the upper part. Damage to the teak post caused by drywood termites was observed on all parts of the post, regardless of the moisture content, and the damage caused by fungi was minimal in this guest house. The bottom part of the post, which has higher moisture content, may be strongly attacked by termites if an infestation of subterranean termites occurred.

The ultrasonic velocities were mostly between 1,500 and 2,000 m/s. The ultrasonic velocity where intense damage caused by drywood termites was observed was less than 1,500 m/s whereas that of a sound post was approximately 2,000 m/s. This indicates that areas where the ultrasonic velocity was near 1,500 m/s may be attacked by drywood termites; there were many holes or galleries in the post though damage was not observed by visual inspection.
