Title: Investigation of Biodeterioration in Indonesian Wooden Structures

Place of survey: Yogyakarta (Indonesia)

Member: Takuro Mori (Assistant Professor, Research Institute for Sustainable Humanosphere, Kyoto University)

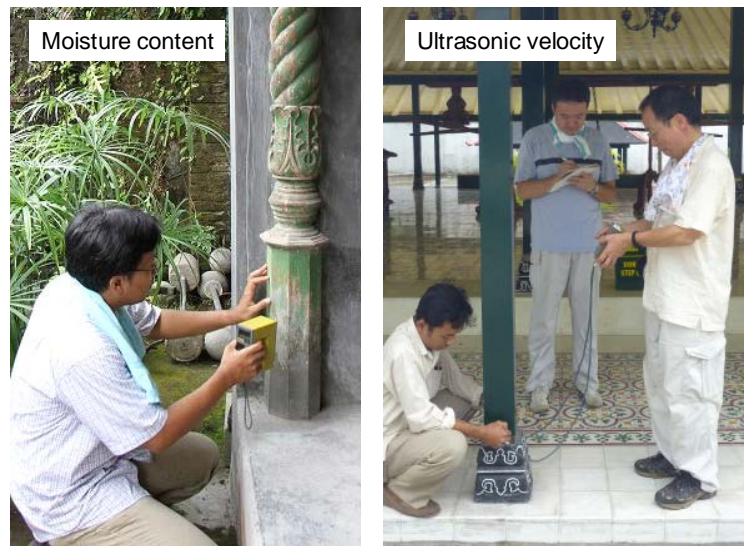
Figure 3. Measurement of moisture content and ultrasonic velocity

Moisture content and ultrasonic velocity were measured on the surface of the teak posts at approximately 300, 1000, and 2000 mm from the ground. A wood moisture tester (HM-530, Kett Electric Laboratory) was utilized to measure the moisture content of teak wood; the specific gravity was set to 0.65. The propagation time of an ultrasonic wave in the teak post was measured using an ultrasonic sound timer (Dr. Wood, Akita SKK Inc.) with an ultrasonic transmitter and receiver. The transmitter and receiver were attached to the surface of the teak post and the propagation time of the ultrasonic wave between the transmitter and the receiver was measured. Ultrasonic velocity was calculated from the propagation time and the distance between the transmitter and the receiver, namely, the width of the teak post. Acoustic emission (AE) generated by termite feeding activity in the wood was also detected using AE measurement apparatus on the teak post. The measurement results of moisture content and ultrasonic velocity are presented in Figure 3.
